KIRKLAND LAKE

A GEOLOGIC SNAPSHOT

Lake Shore Mine Tailings Project

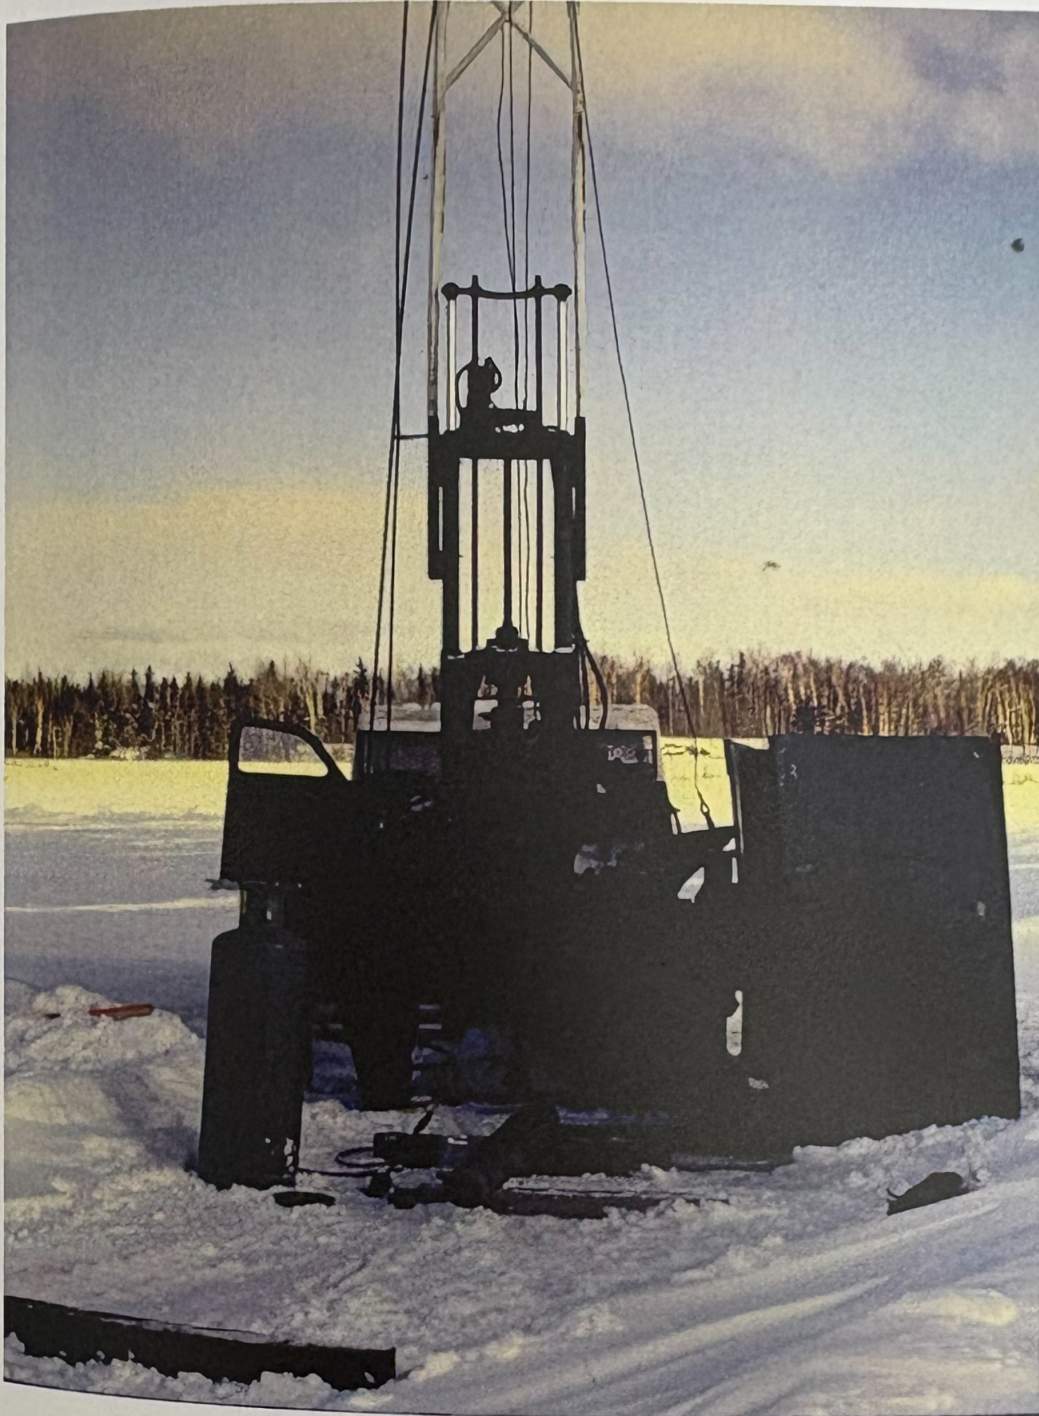
The photograph in Figure 33 is that of the Marathon auger rig used to delineate the remaining tailings in the former Kirkland Lakebed so that a Resource estimate could be compiled.

Figure 33: Auger & Split Spoon Drill Evaluating Tailings Tonnage and Au Grade

The quality and quantity of available tailings was first locally investigated with a power shovel and then by a split spoon drill sampling program, conducted over the lakebed where the greatest quantity of Lake Shore tailings were deposited. Keep in mind that all the individual mine operations discarded their tailings in the closest depressions to their mill locations until more distant sites were required, accessing these in the neighboring townships. Since the property boundary between Teck Hughes and Lake Shore Mines was the shoreline waters of Kirkland Lake, tailings ownership limits were not clearly marked.

The power shovel work was followed by the surface split spoon drilling campaign, with both the writer and Doug Cater conducting the drilling program during the winter months with Marathon Drilling from Ottawa. An earlier, small tailings recovery dredging campaign behind the hoistrooms created a small pond about 100 feet across and about 15 feet deep. The winter ice was thickened up and then the tailings were sampled down to the original lakebed contact. Figure 35 picture shows Doug Cater preparing to capture the fluid-like tailings from the split spoon.

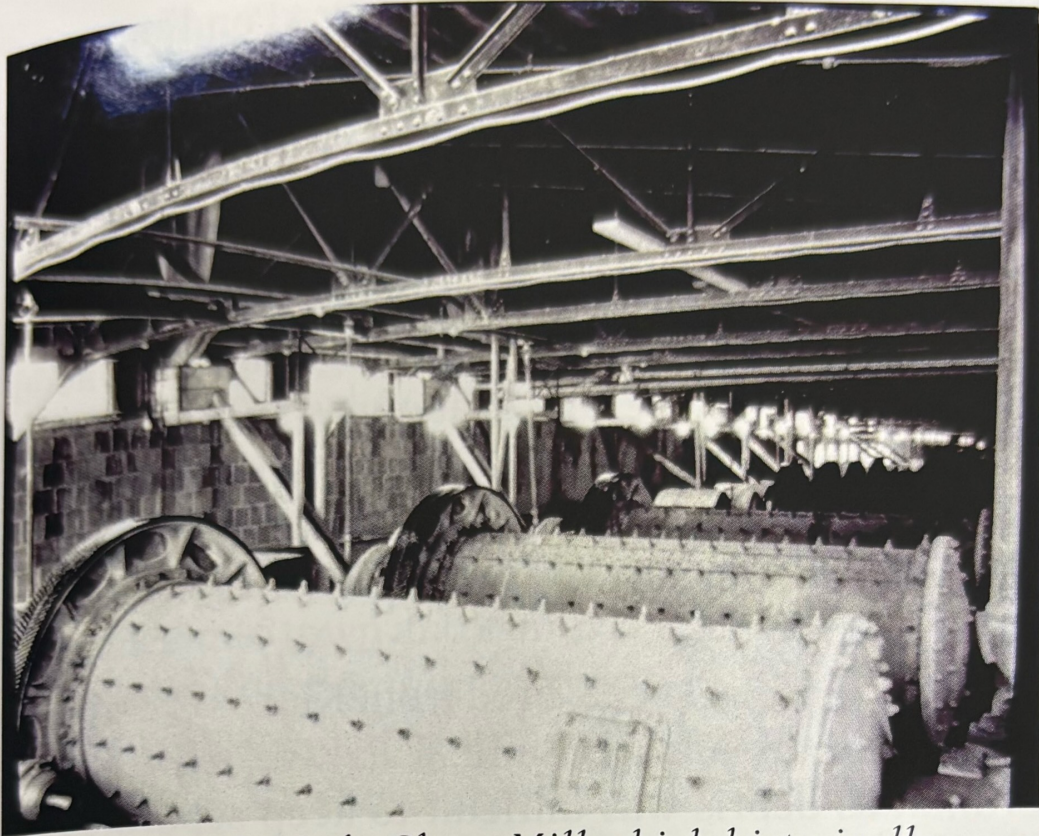
Figure 34: Lake Shore Mill which historically processed 2000 TPD.

While the Lake Shore Mine was operating until about 1956 the mill processed ore at a rate of 2000 TPD. A smelter/roaster also treated some ores but no detailed information was found on this process.

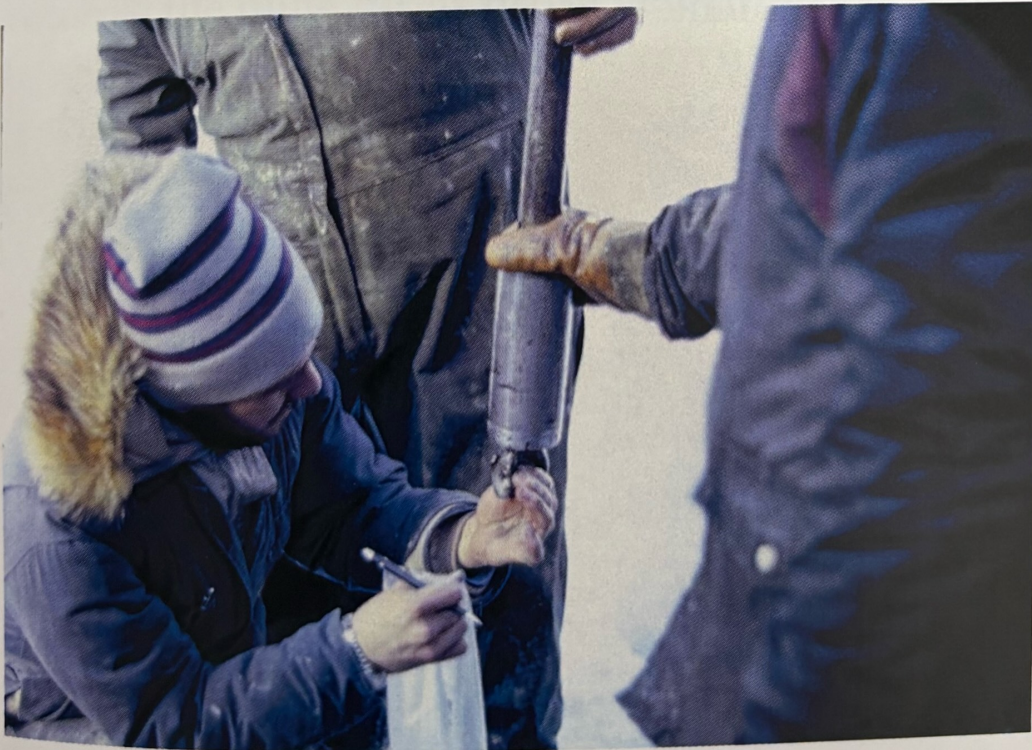
Figure 35: Doug Cater Recovering Tailings Sample from Tube

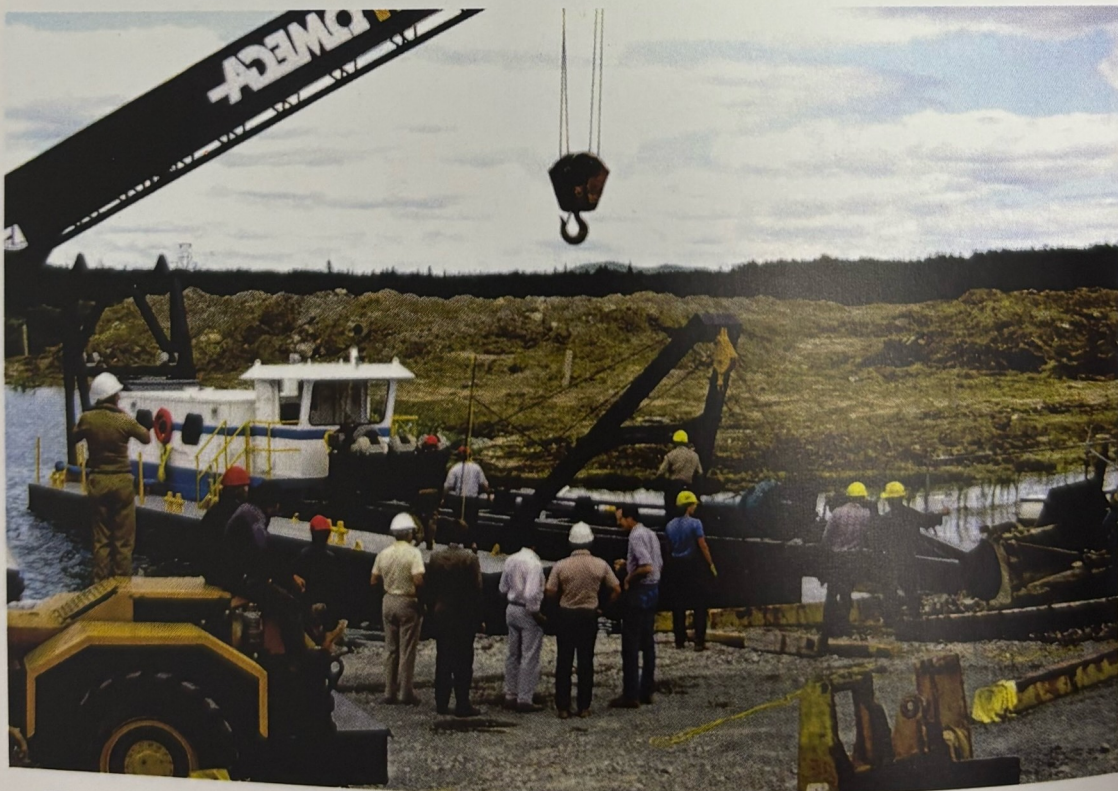
Figure 36: Launching of the Lady LAC Tailings Dredge

The tailings in behind the mall were recovered with the Lady LAC dredge and piped to the Macassa mill for treatment.
